TS-PIC-92762
April 1992

AERIAL PHOTOGRAPHIC ANALYSIS OF LACLEDE GAS

St. Louis, Missouri

ENVIRONMENTAL MONITORING SYSTEMS LABORATORY
OFFICE OF RESEARCH AND DEVELOPMENT
U.S. ENVIRONMENTAL PROTECTION AGENCY
LAS VEGAS, NEVADA 89193-3478

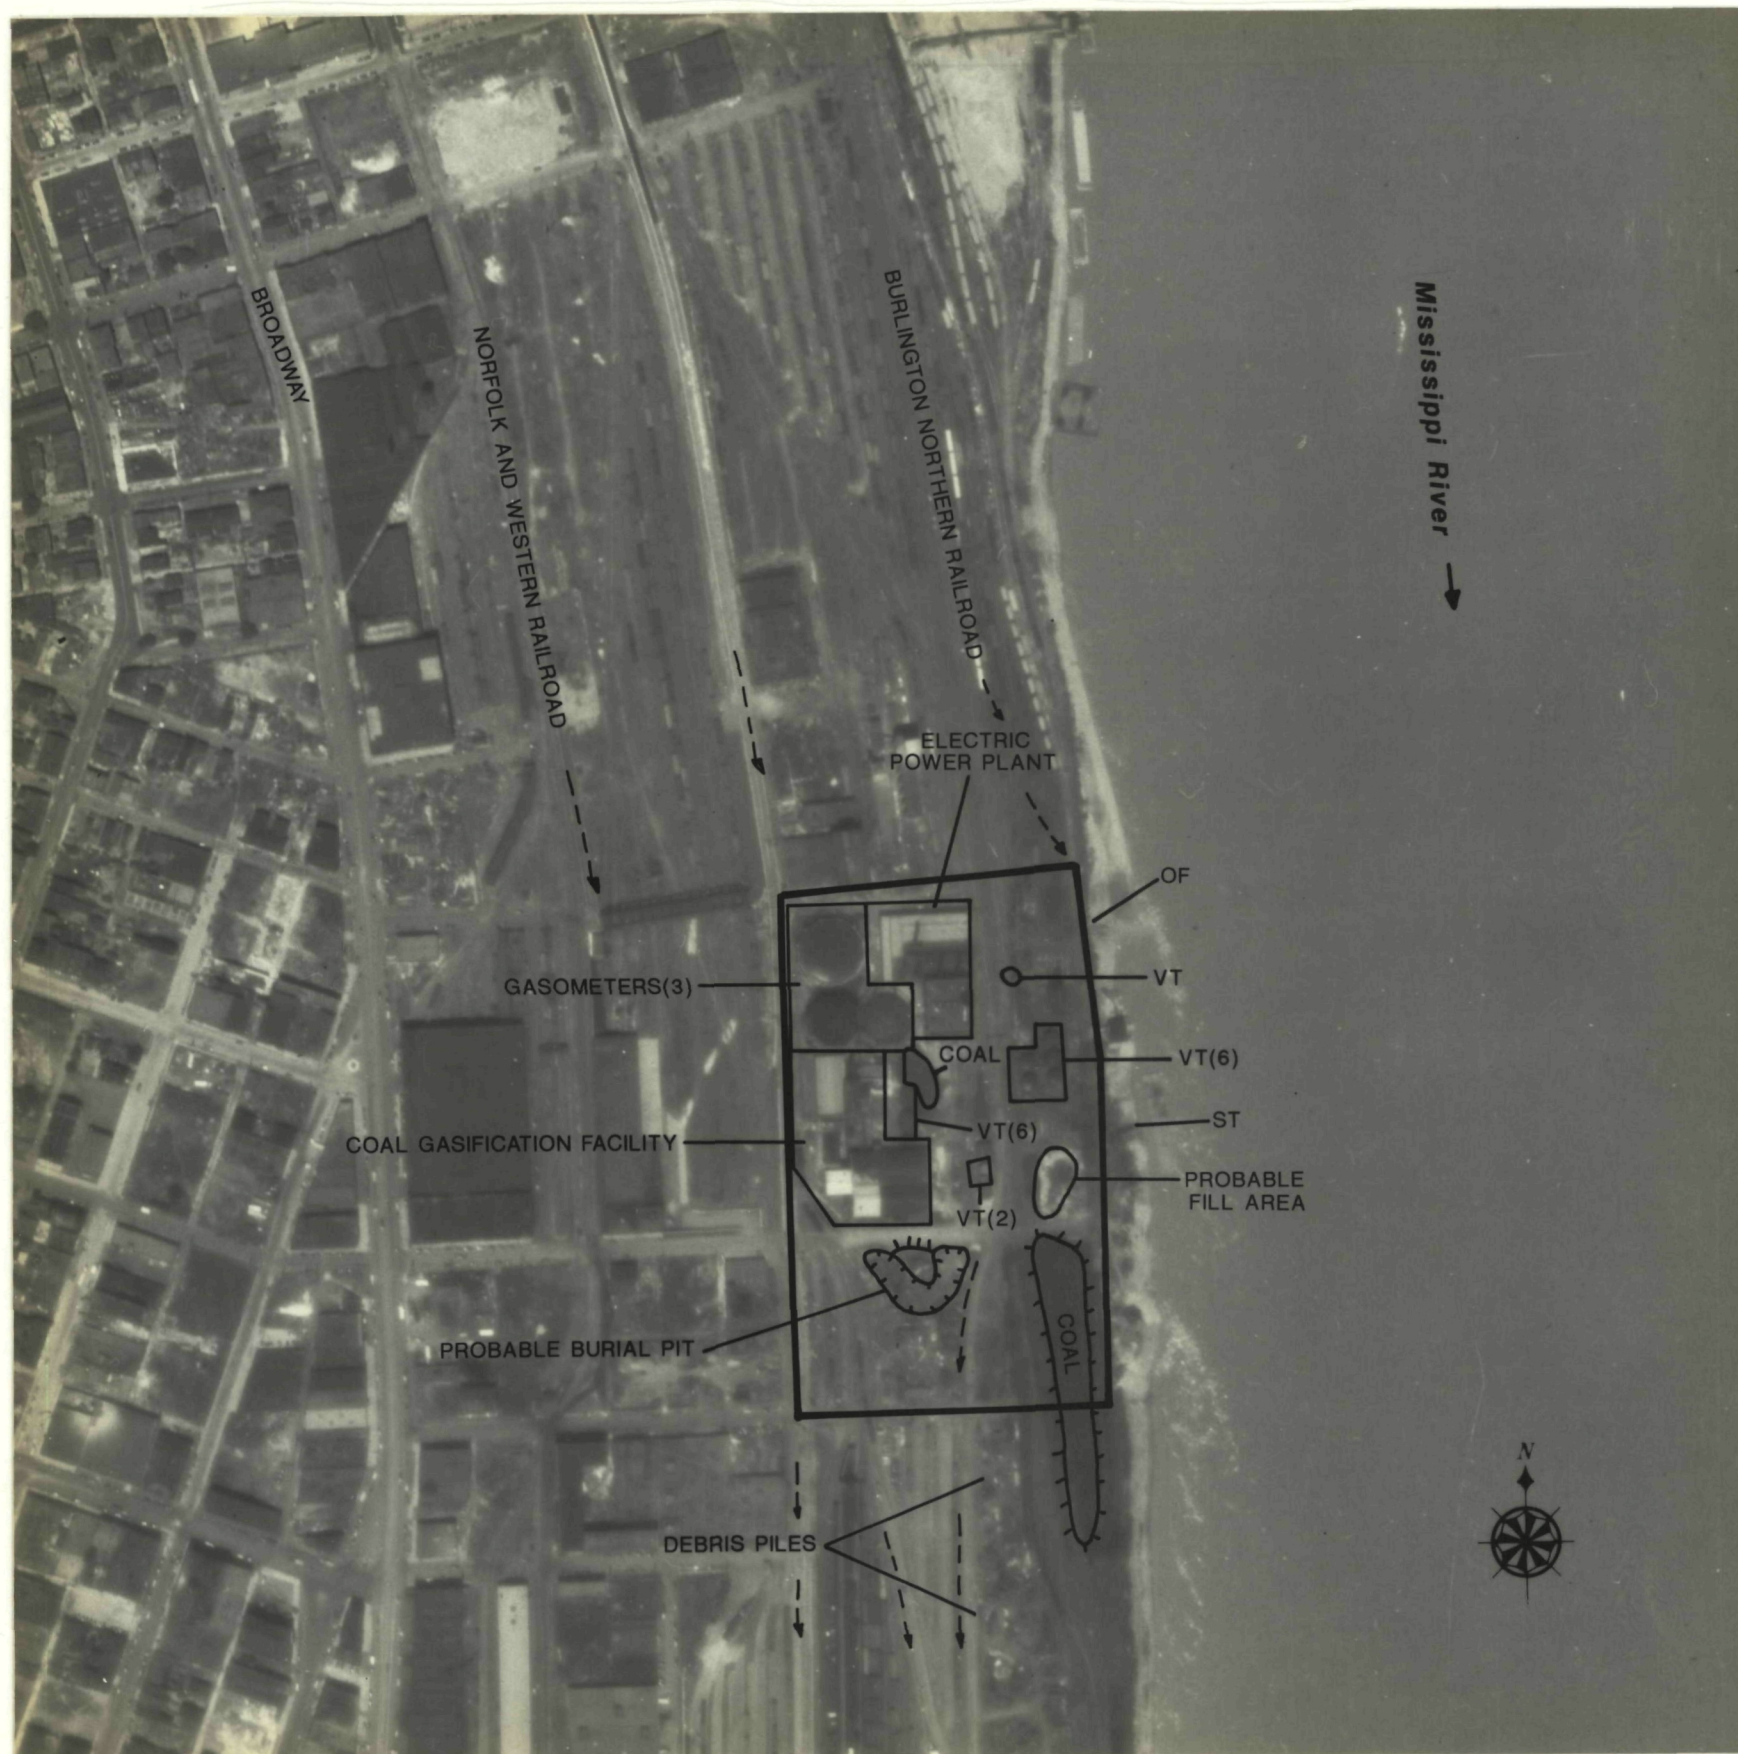
Figure 3. Laclede Gas, July 17, 1941. Approximate Scale 1:4,510.

Two principal features of the analysis, an electric power plant and coal gasification facility, are located in the northwest portion of the site. A conduit discharging liquid (OF) into the river, is probably associated with the electric power plant. The three large gasometers observed to the immediate north of the coal gasification plant are components of the facility. The three gasometers observed, have attained different degrees of height. The height of the individual gasometers are proportional to their gaseous content.

An excavation in the southern portion of the site appears to be a burial pit containing scattered debris. A linear streak extending from the upper to lower portions of the river bank is dark-toned and probably a liquid stain. Above the stain is a fill of unidentified material.

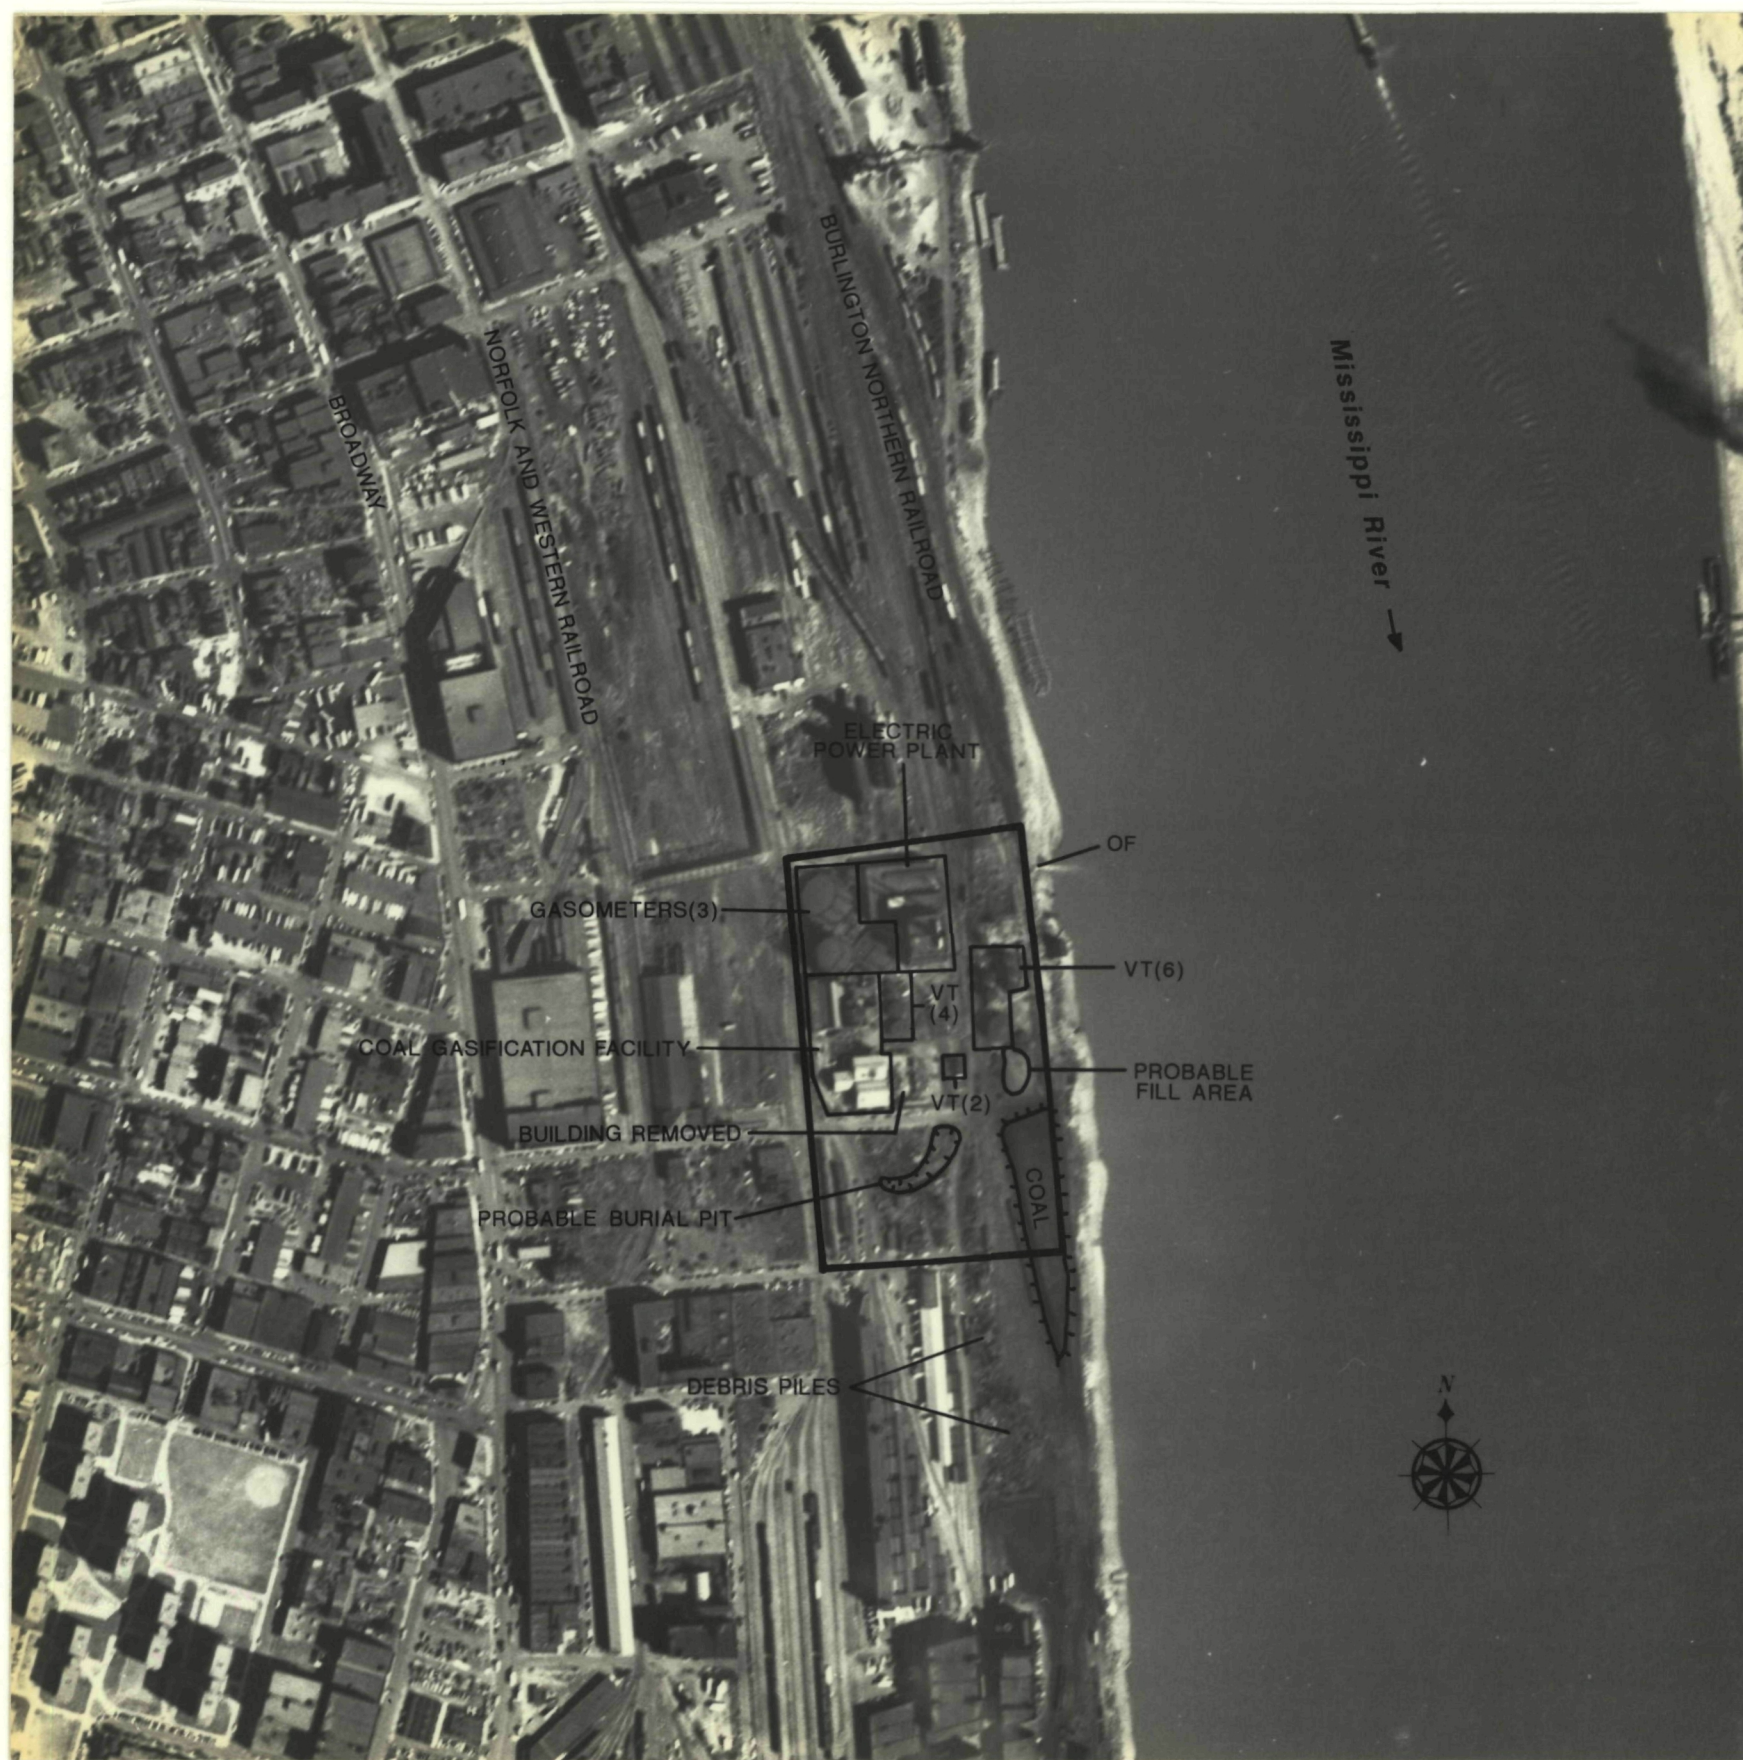
Figure 4. Laclede Gas, September 8, 1953. Approximate Scale 1:5,740.

The 1953 photography shows the partial dismantling of the coal gasification facility. A building in the southeast portion of the facility and two vertical tanks adjacent to the building have been removed.

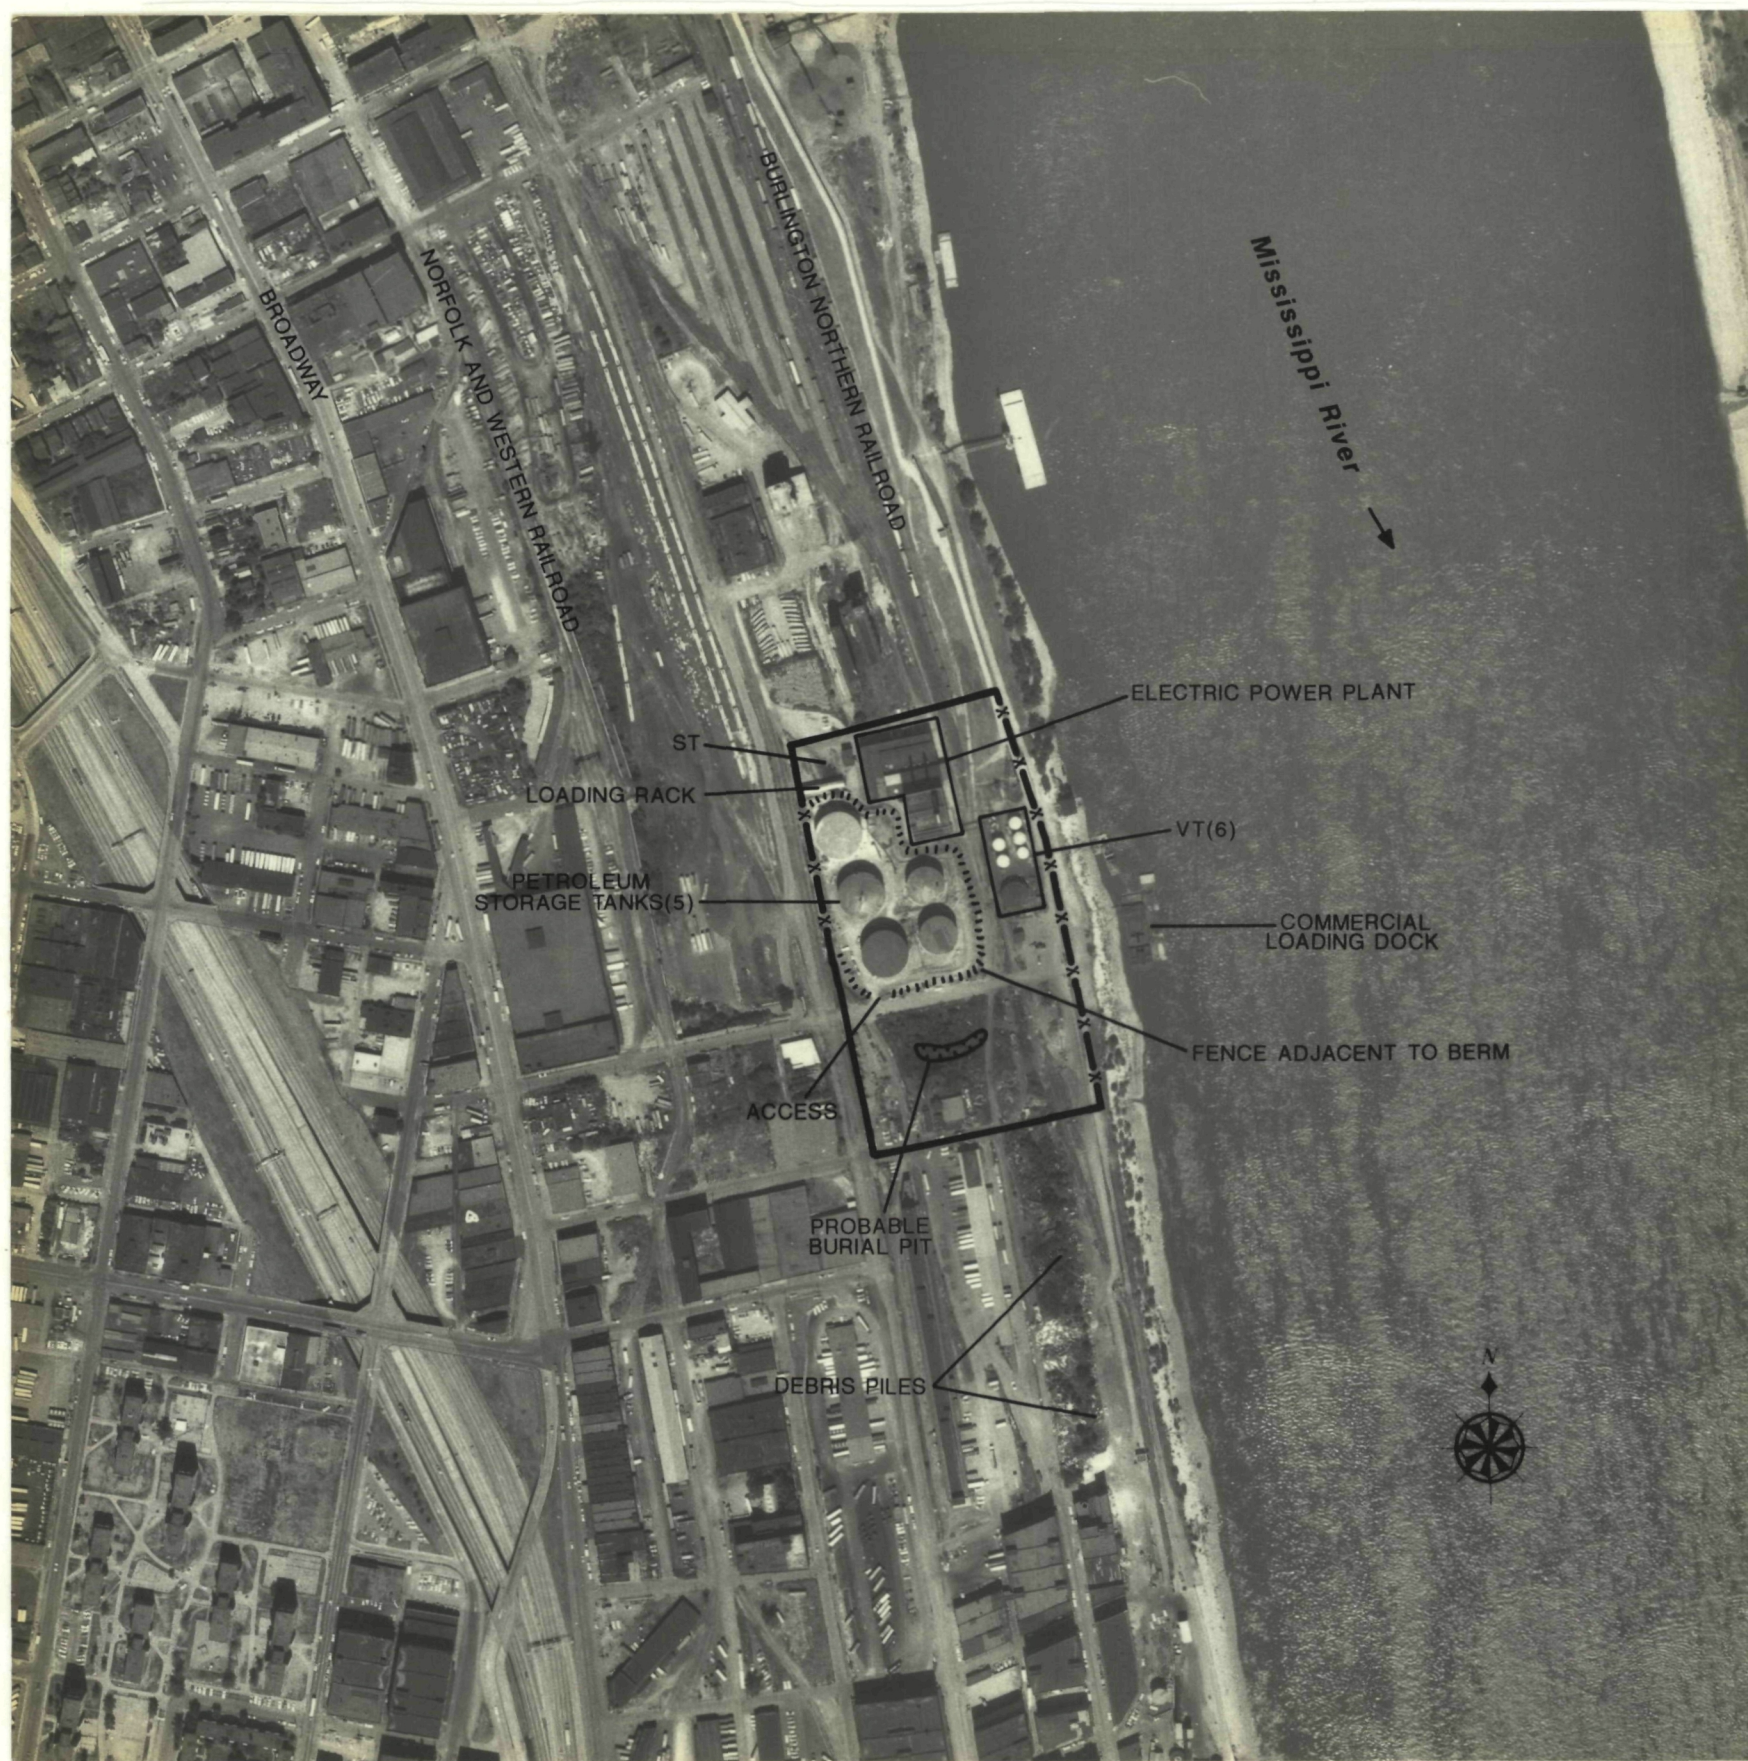
Figure 7. Laclede Gas, August 26, 1971. Approximate Scale 1:5,580.

The 1971 photography shows the emplacement of five vertical petroleum storage tanks in the area previously occupied by the coal gasification facility. The petroleum tanks are contained by a berm and secured by a perimeter fence. A dark toned stain has been observed adjacent to the loading rack immediately north of the storage tanks.

The conduit discharging liquids into the Mississippi River is not evident on this years photography. The operational status of the electric power plant cannot be discerned.

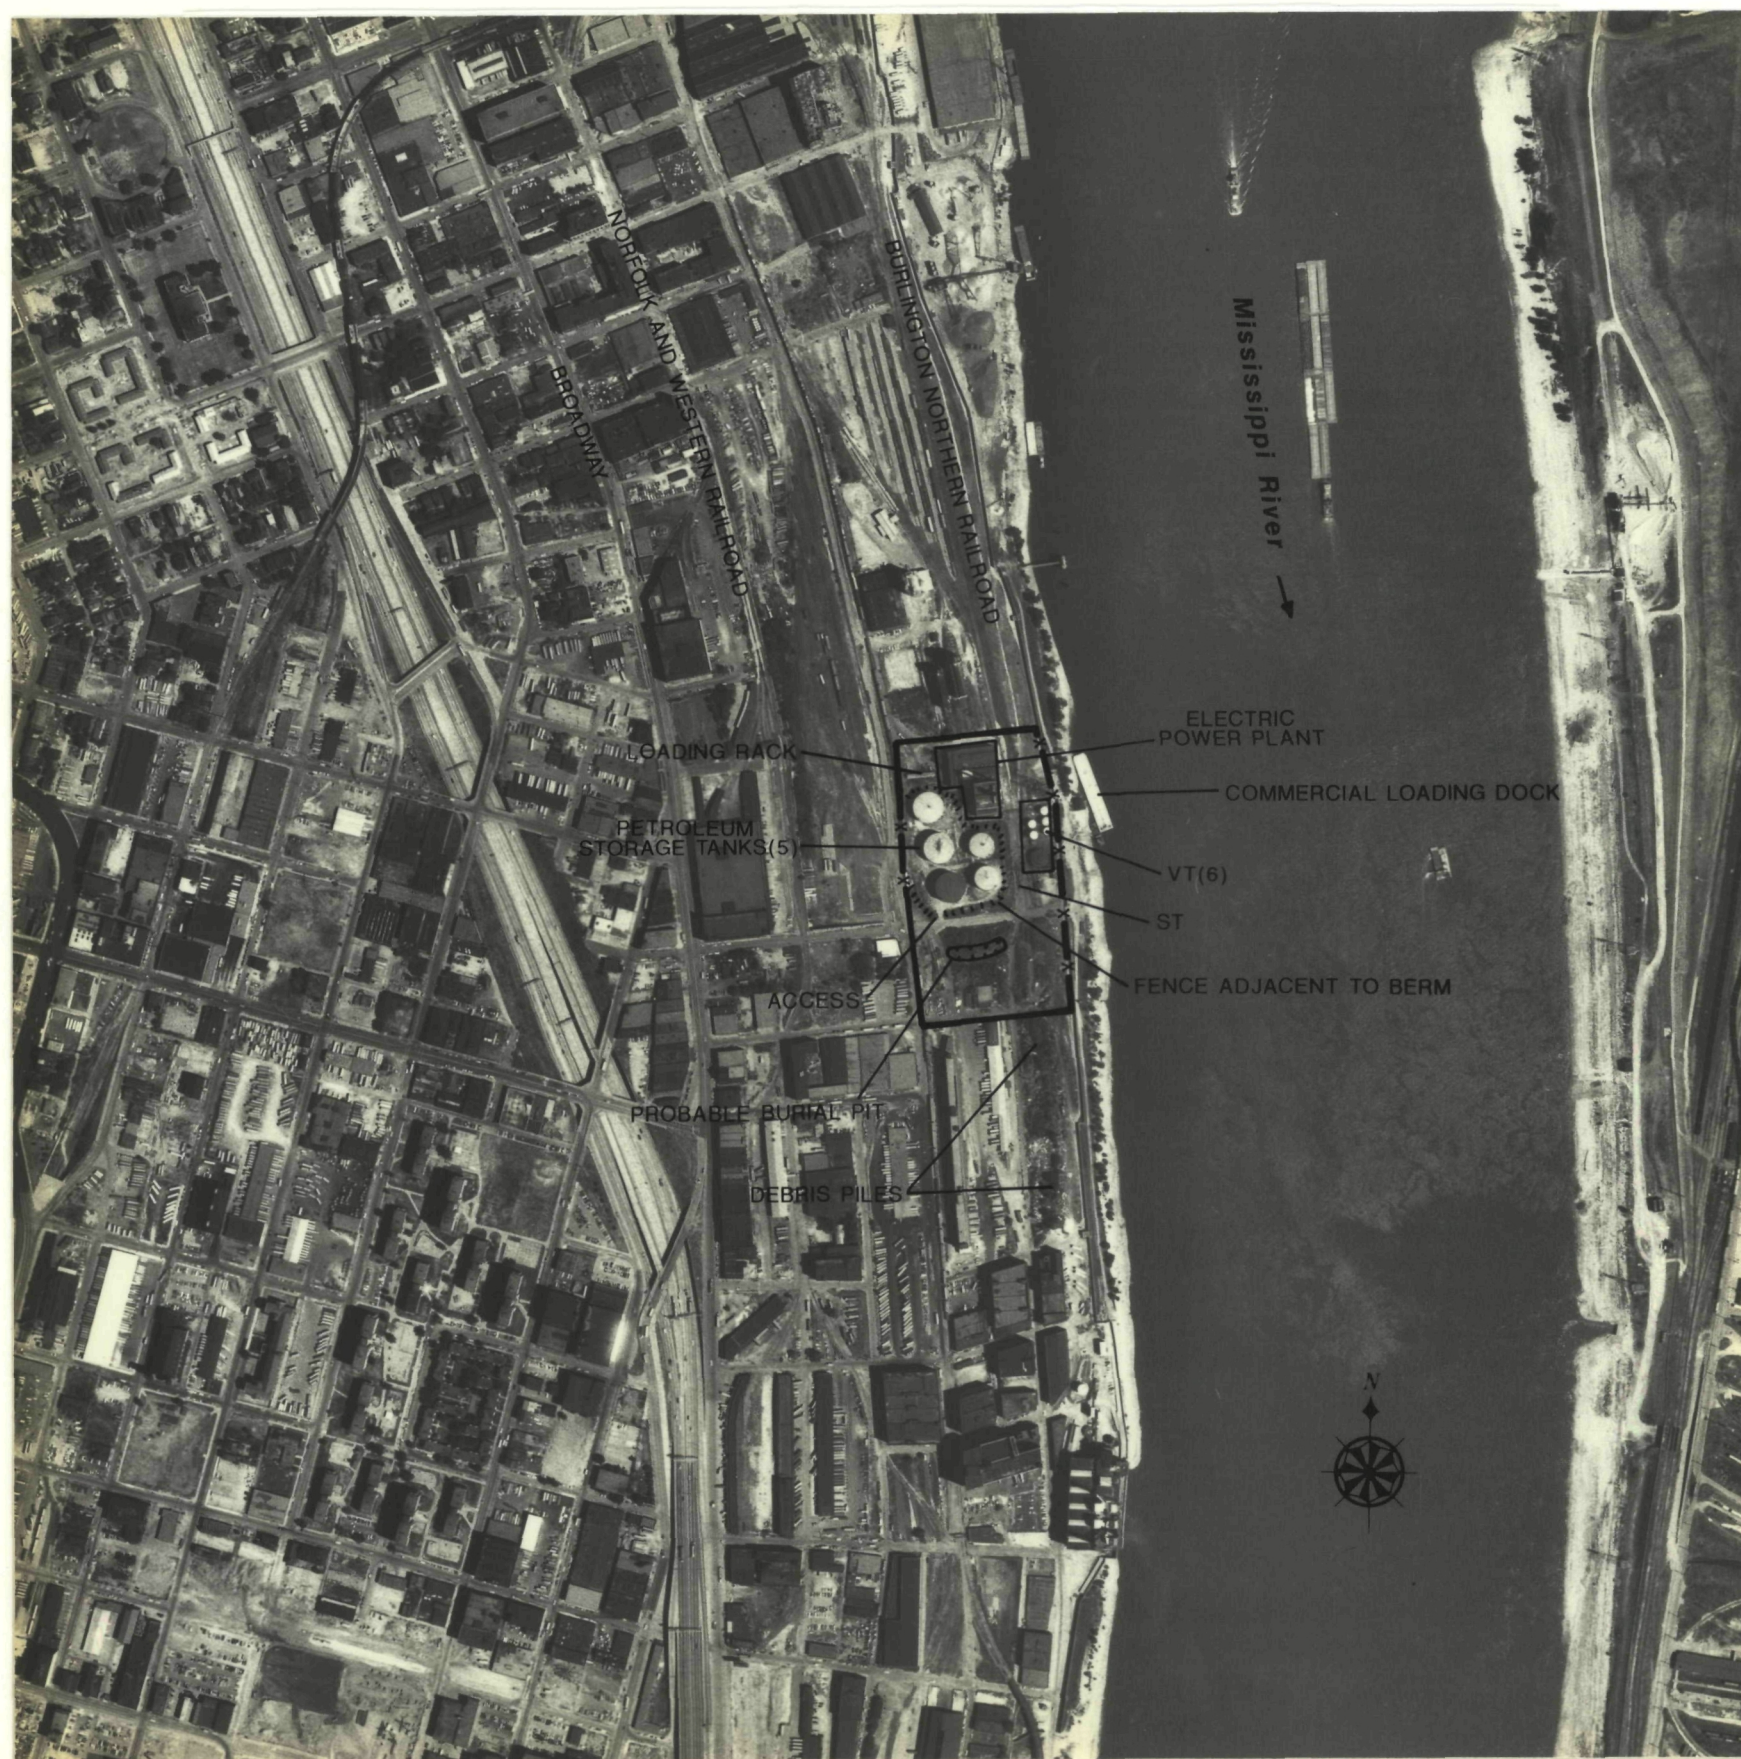
Figure 8. Laclede Gas, July 30, 1974. Approximate Scale 1:8,460.

The 1974 photography reveals no significant alterations to the site.

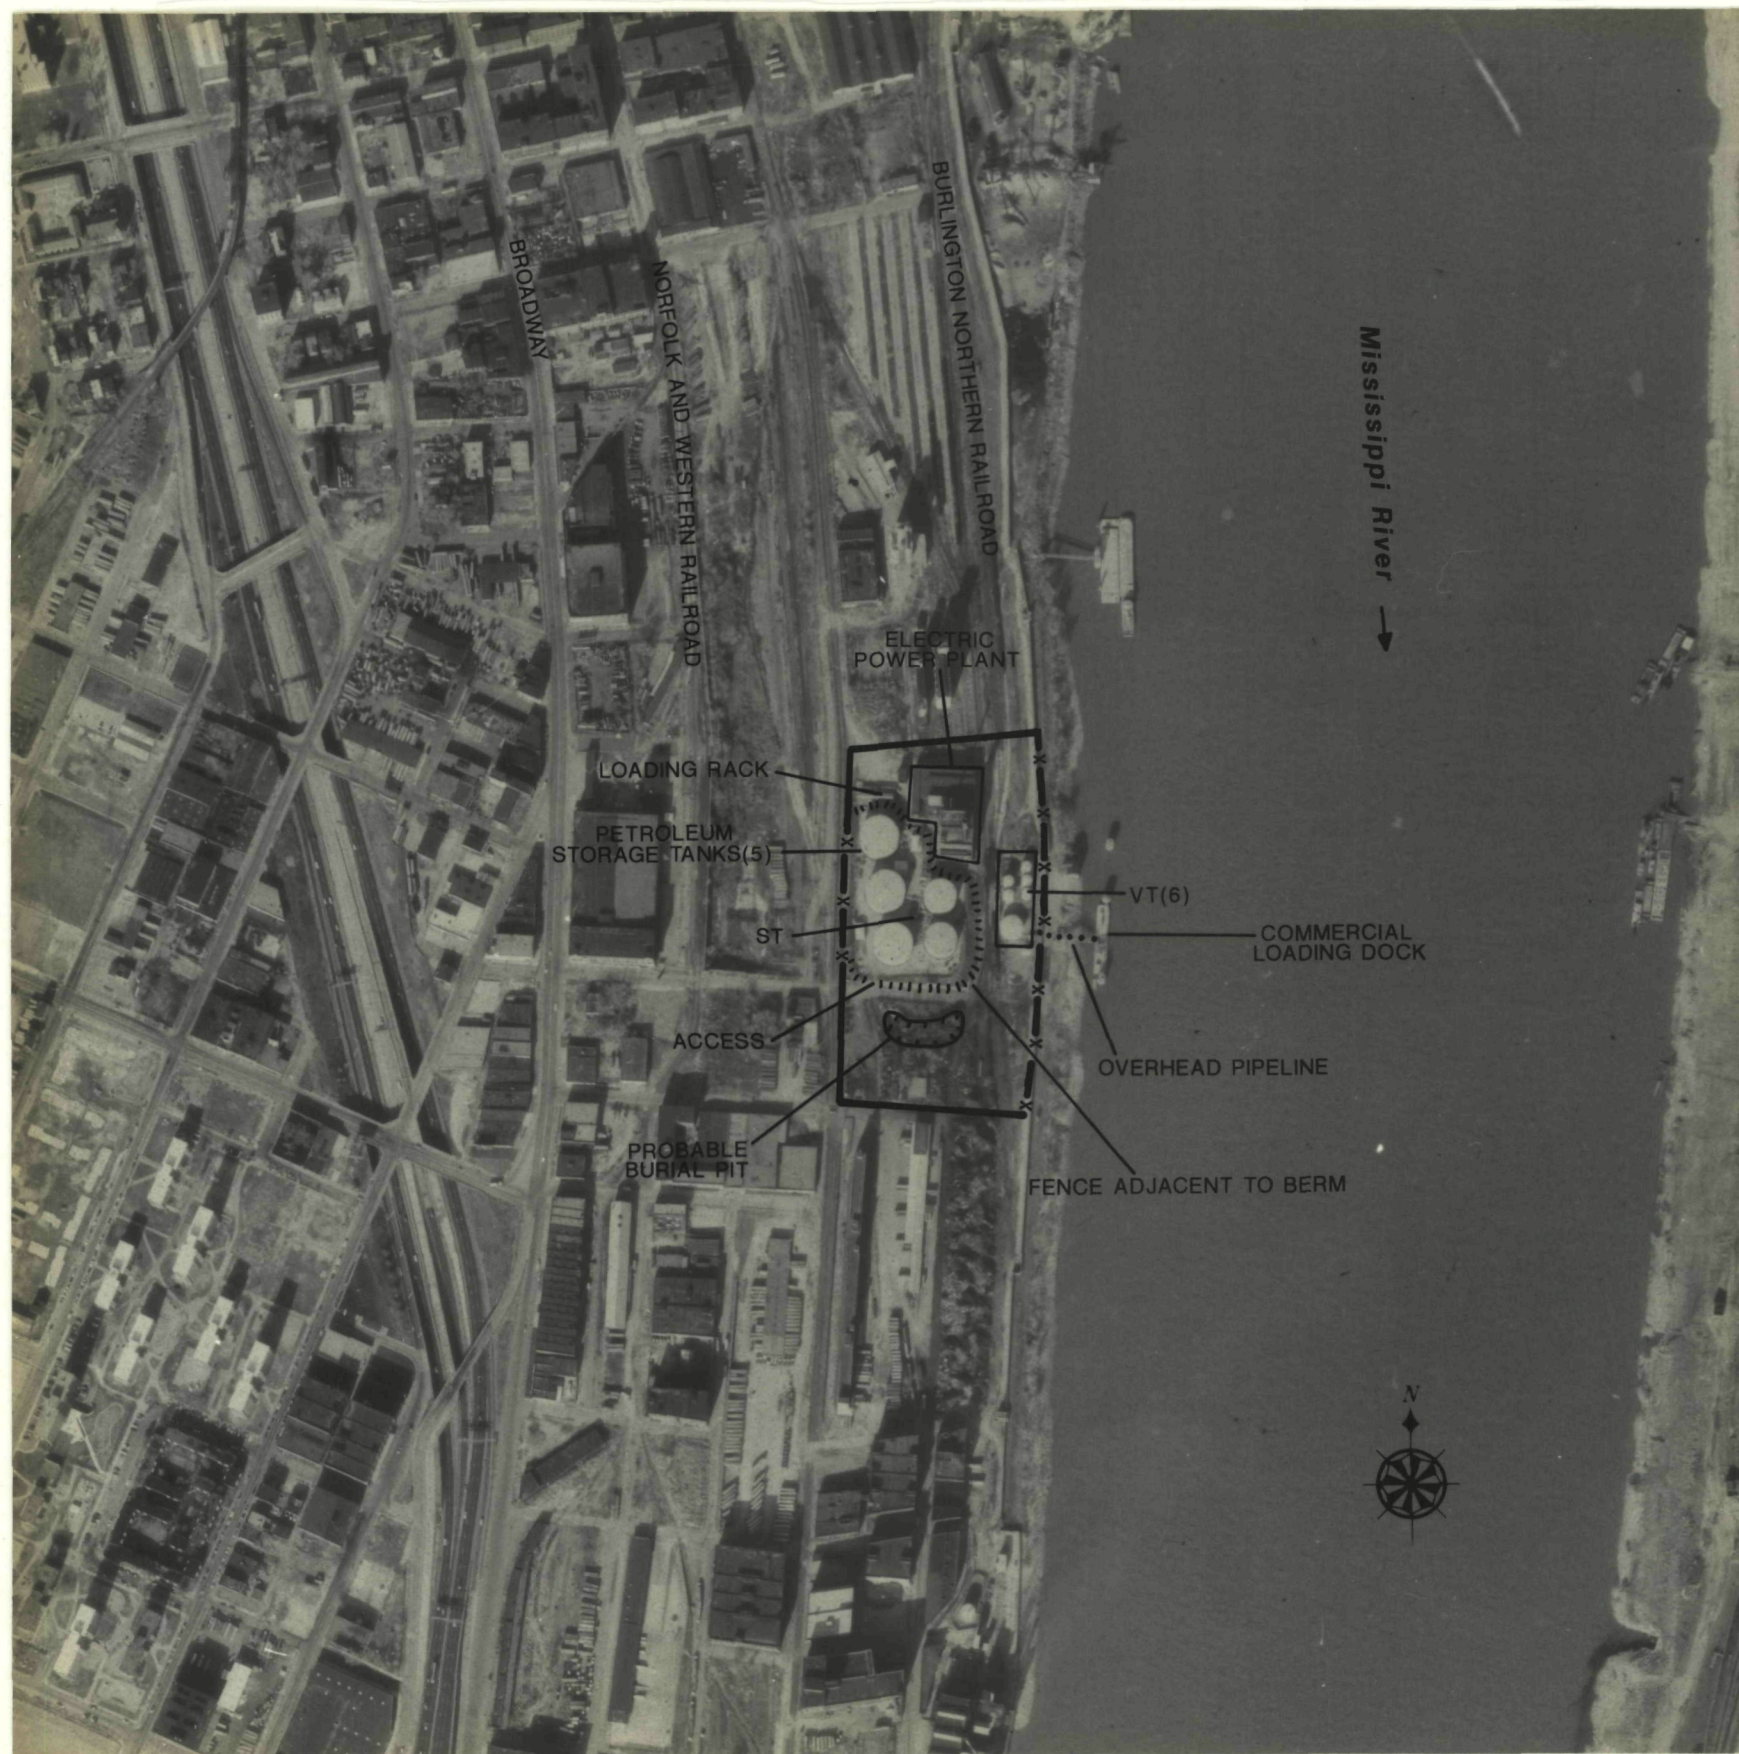
Figure 9. Laclede Gas, December 14, 1980. Approximate Scale 1:6,530.

The 1980 photography reveals the placement of a commercial loading dock on the Mississippi River directly east of the site. An overhead pipeline positioned on the loading dock, extends east, entering the eastside of the site. A dark-toned stain is identified underneath the piping which interconnects the petroleum storage tanks.

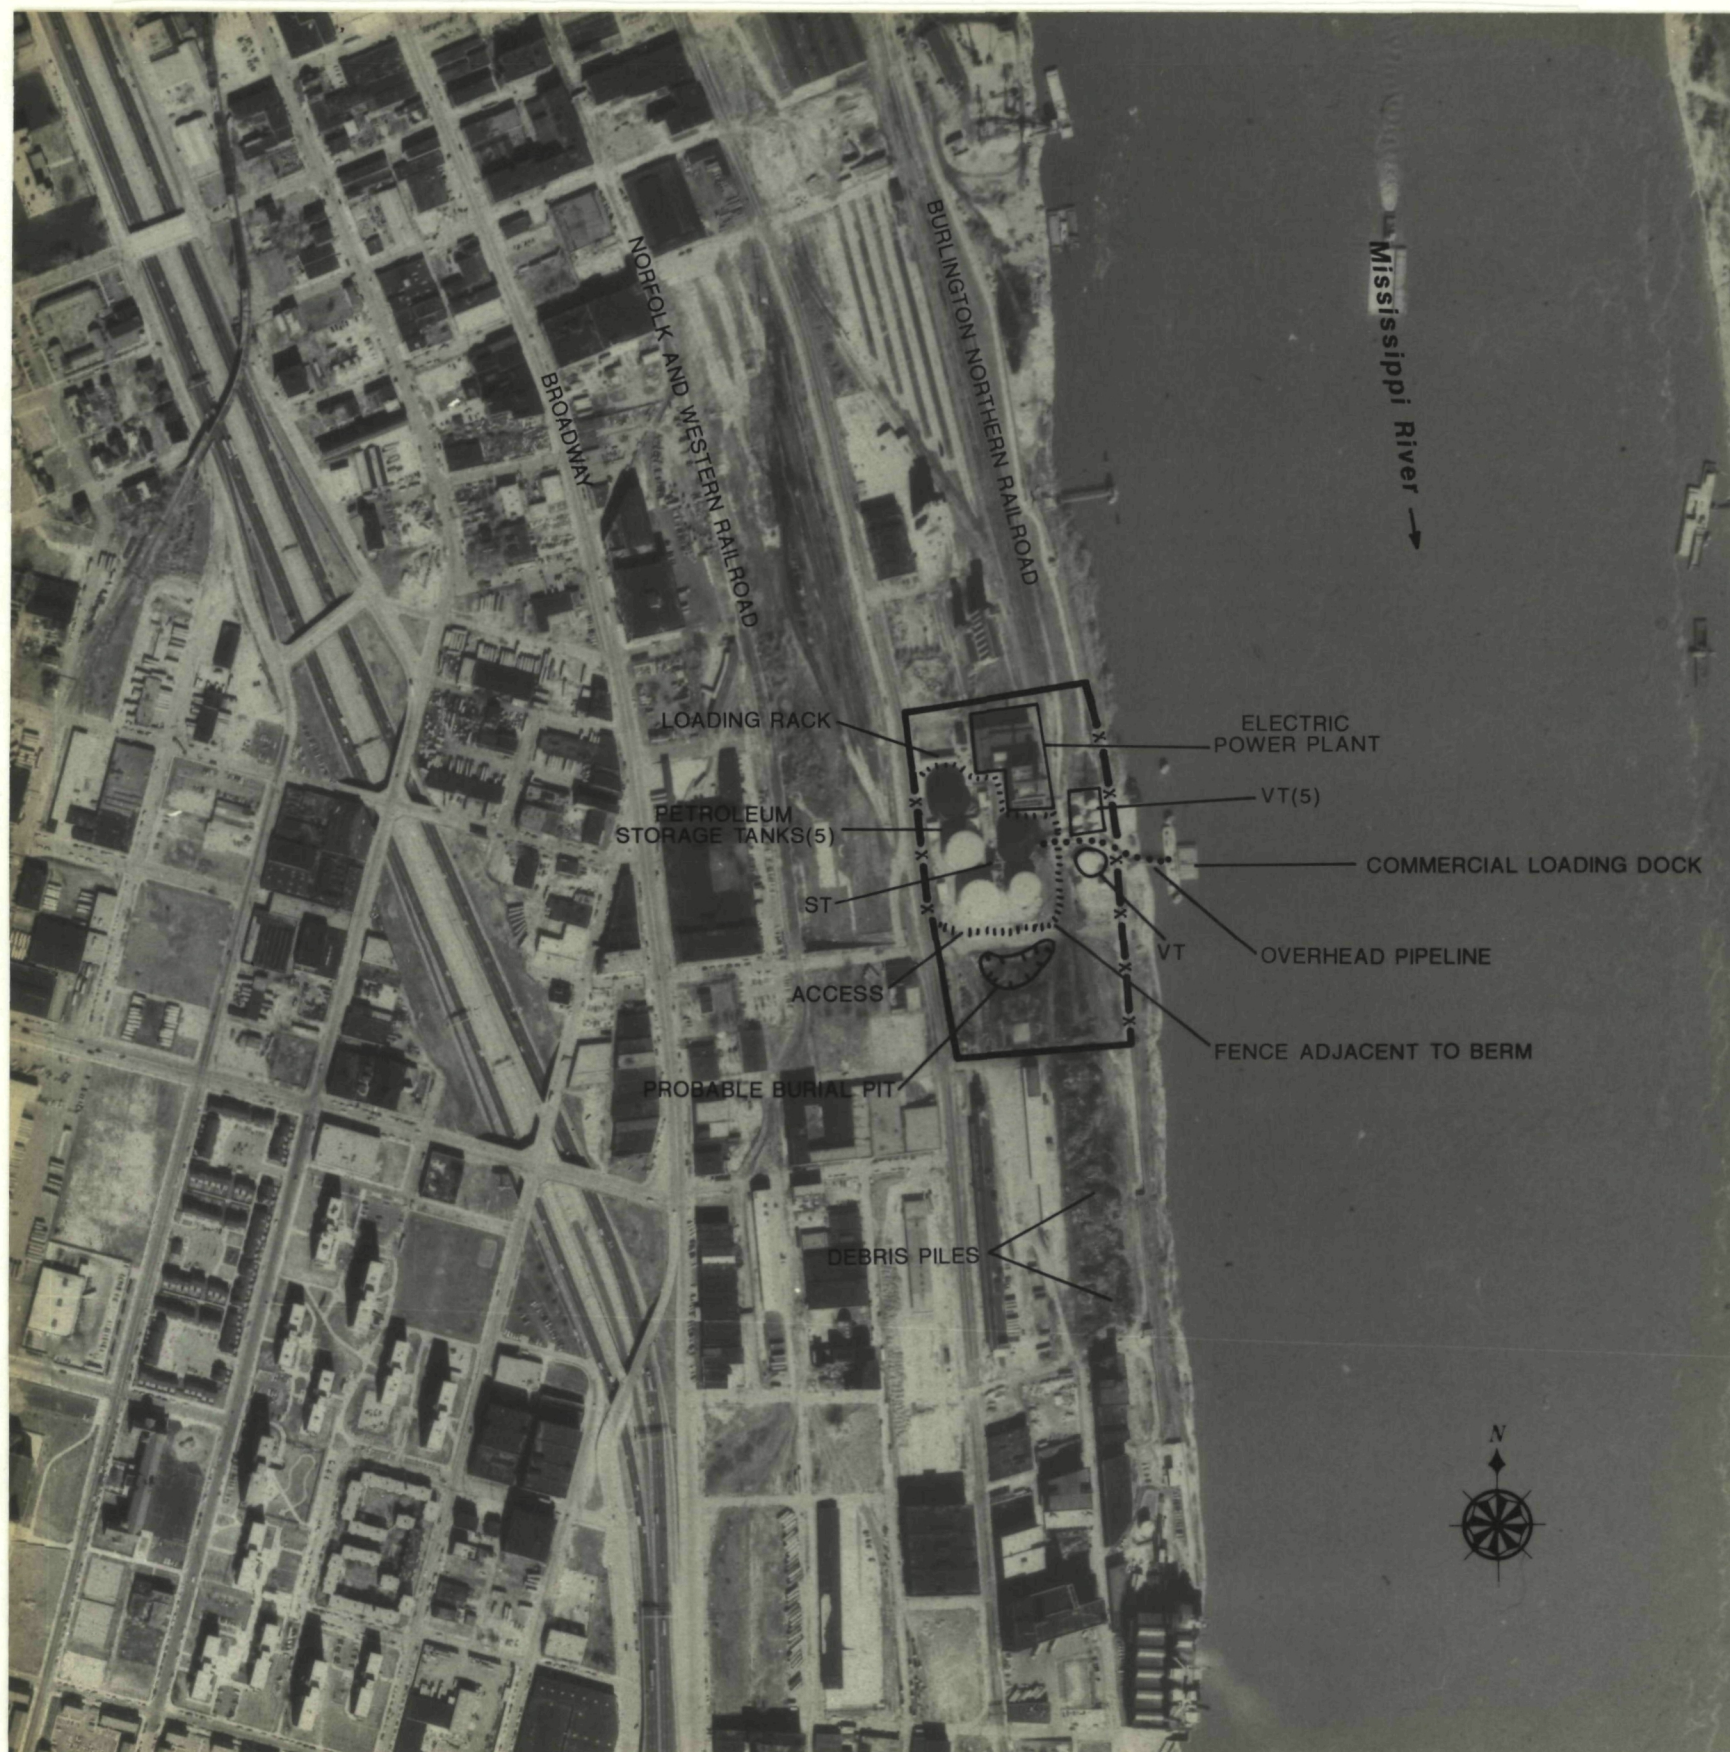
Figure 10. Laclede Gas, February 21, 1984. Approximate Scale 1:6,750.

No significant changes have been observed on the 1984 photography

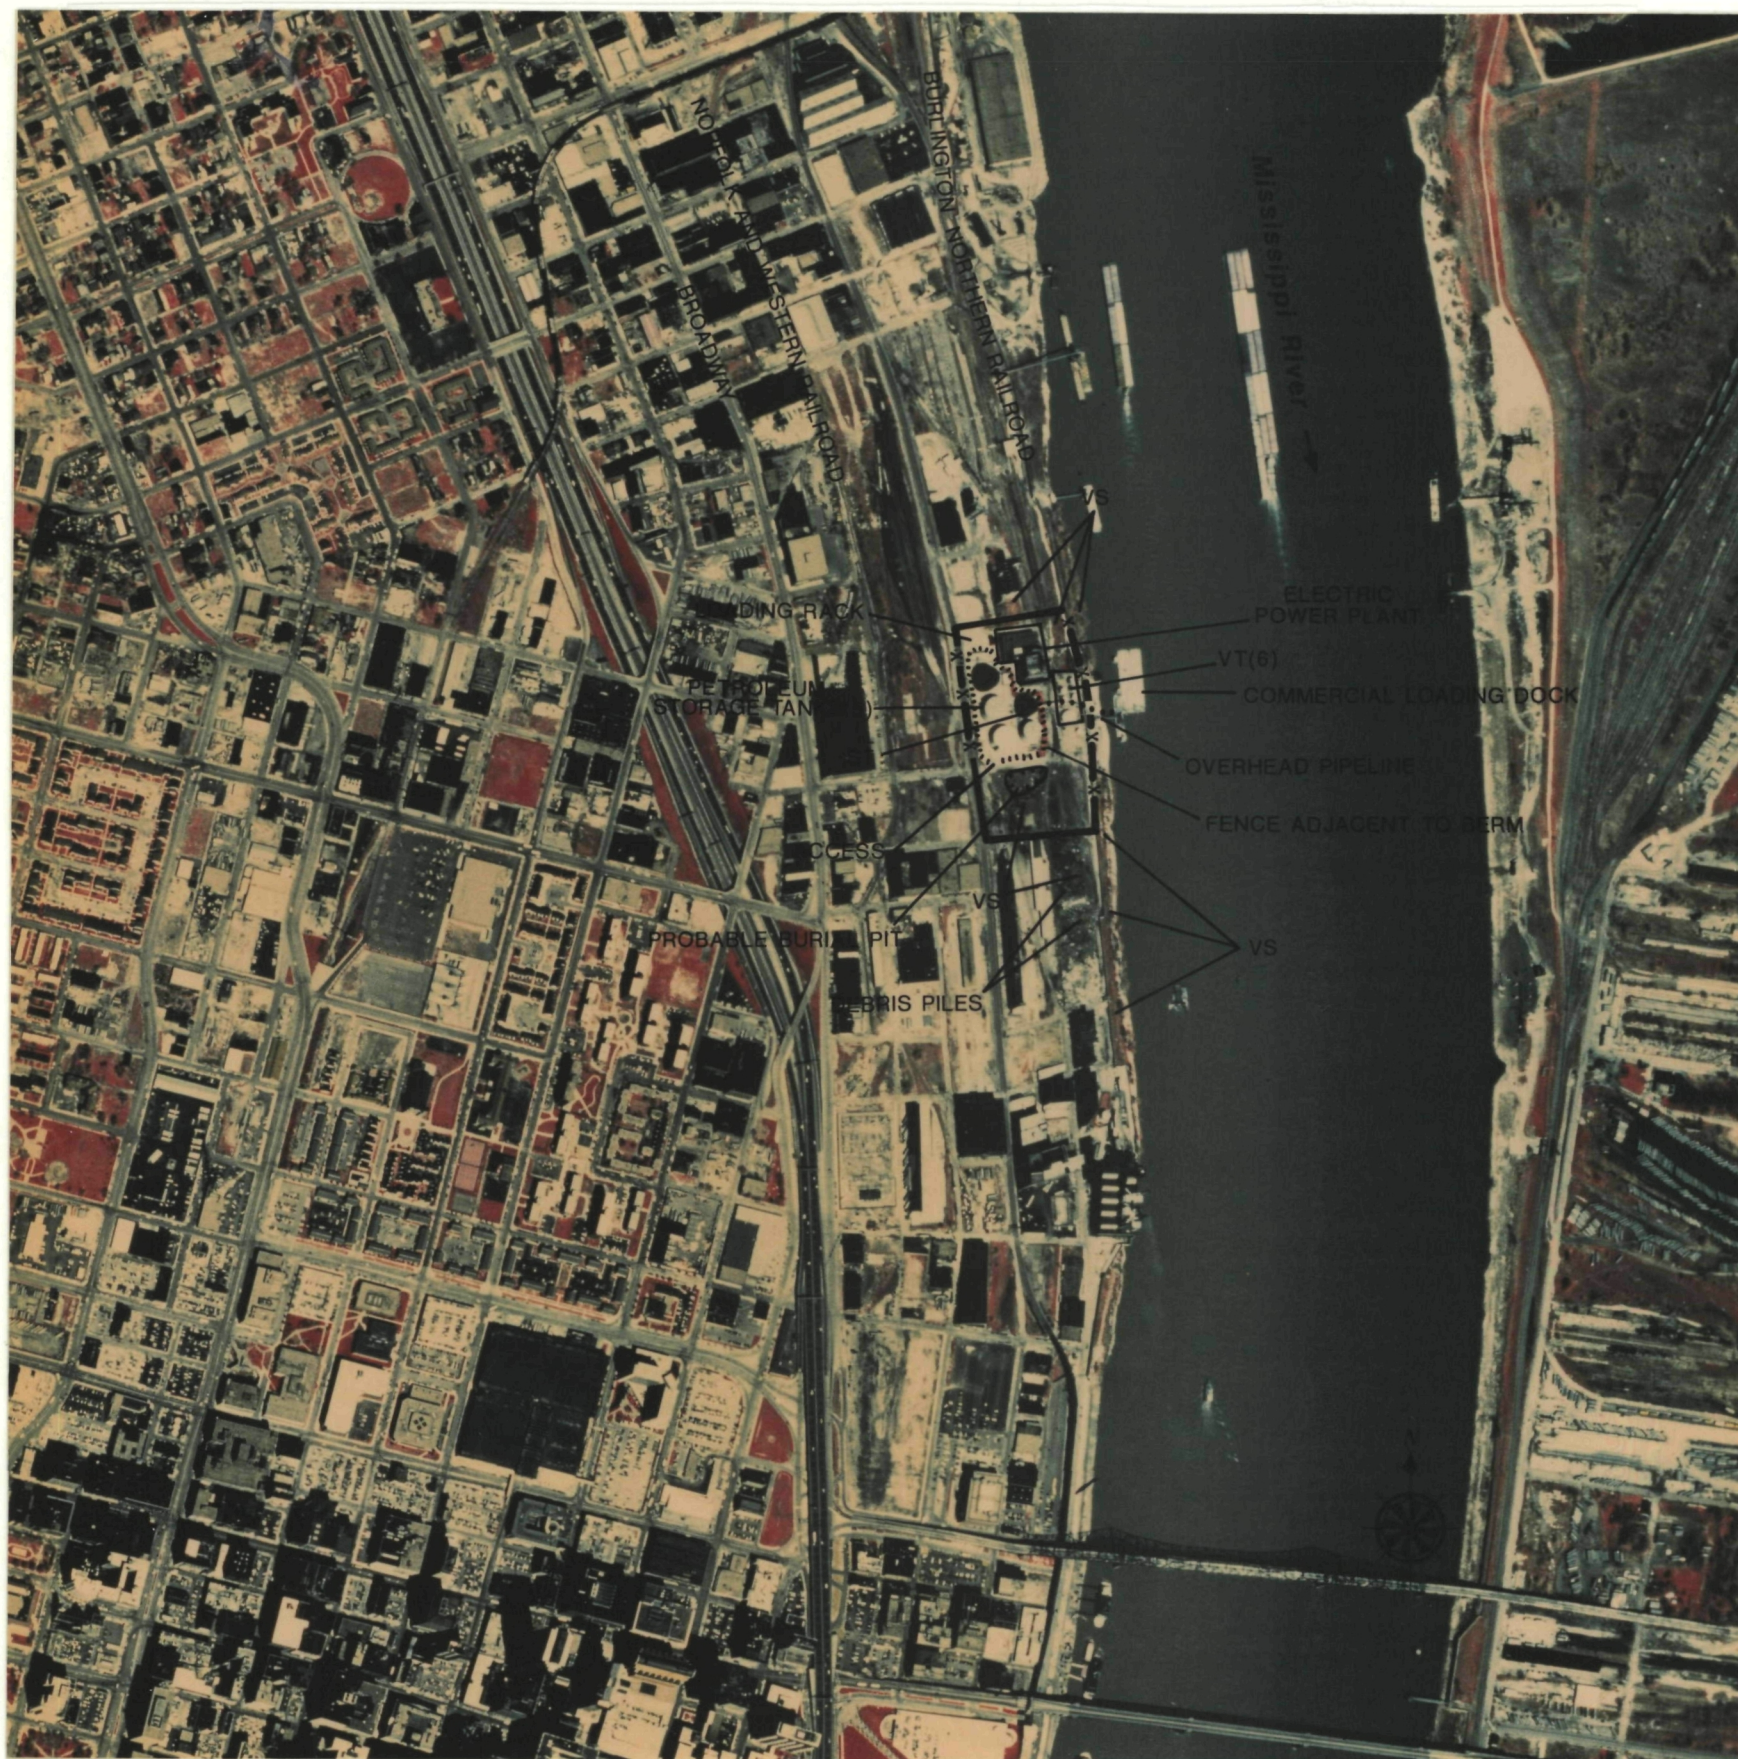
Figure 11. Laclede Gas, April 7, 1988. Approximate Scale 1:10,860.

The 1988 color infrared photography is an excellent source for the identification of vegetation stress. Areas of suspected vegetation stress have been observed along the banks of the Mississippi River, in the southern portion of the site, and areas to the immediate north and south of the site.
